Forensic Building Science, Inc.
657 Lincoln Avenue
St. Paul, MN 55105
T: 651.222.6509
www.forensicbuildingscience.com

Date: January 22, 2018

Property: Rocky Waters Motor Inn
333 Parkway,
Gatlinburg, TN 37738

This letter will serve as an interpretation with recommendations from our particulate matter sampling at the above referenced property. Air sampling and tape lift sampling was performed by Forensic Building Science (FBS) on January 4 and 5, 2018 in response to a recent brush fire.

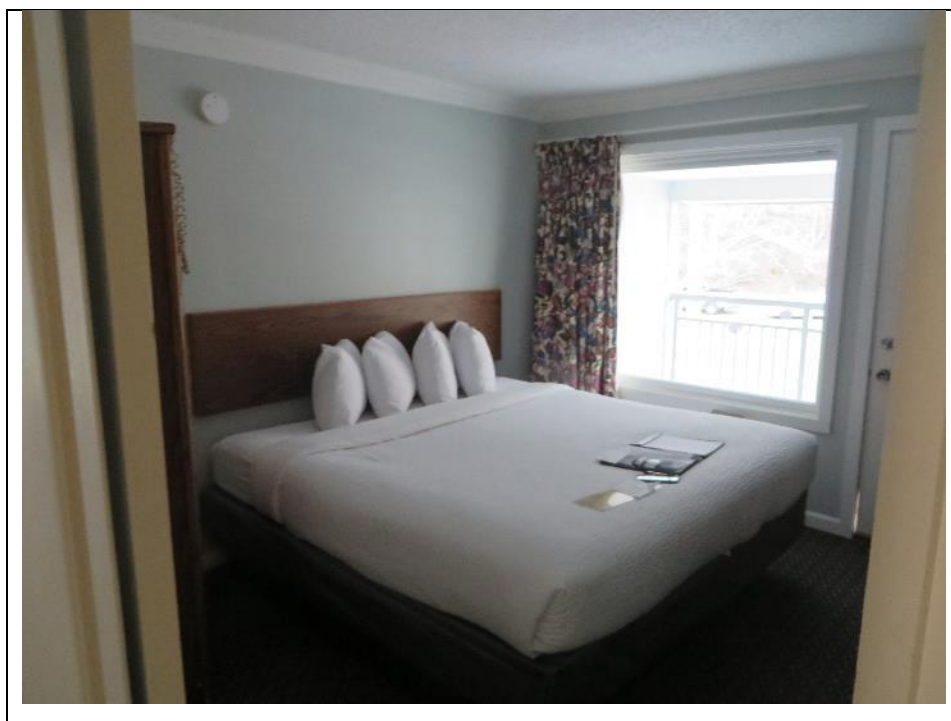
Figure 03. Bedroom overview. (AP)

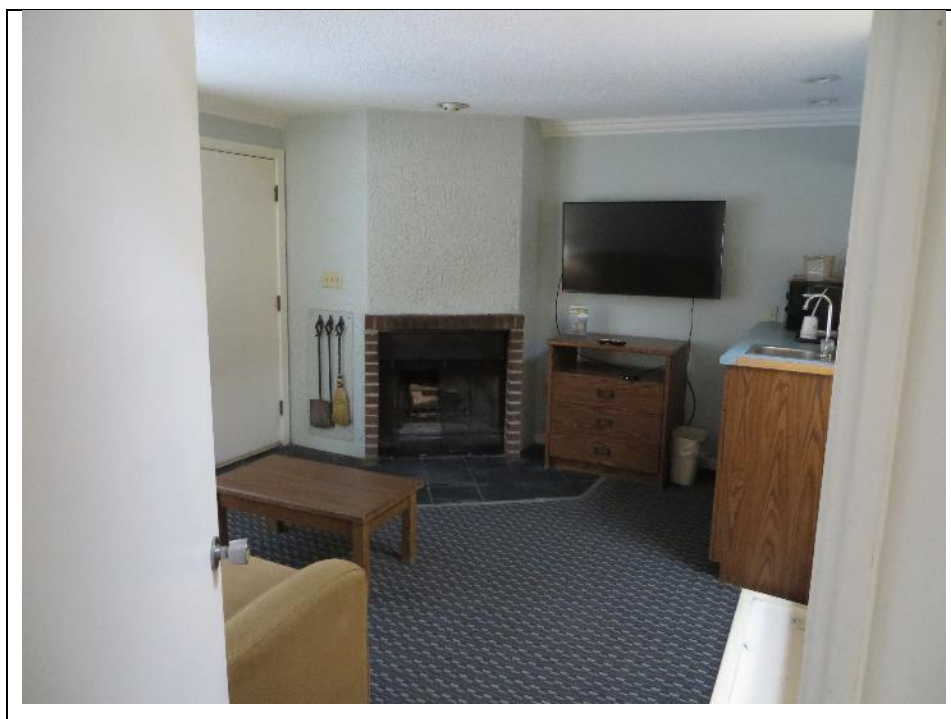
Figure 04. Living area overview. (AP)

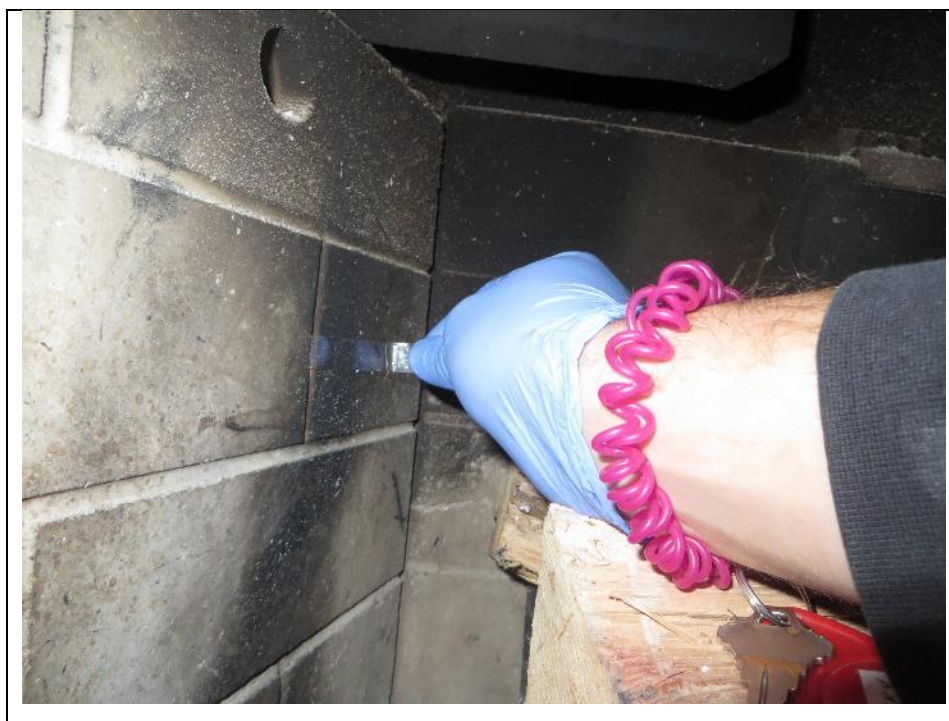
Figure 07. For base line comparison (AP)

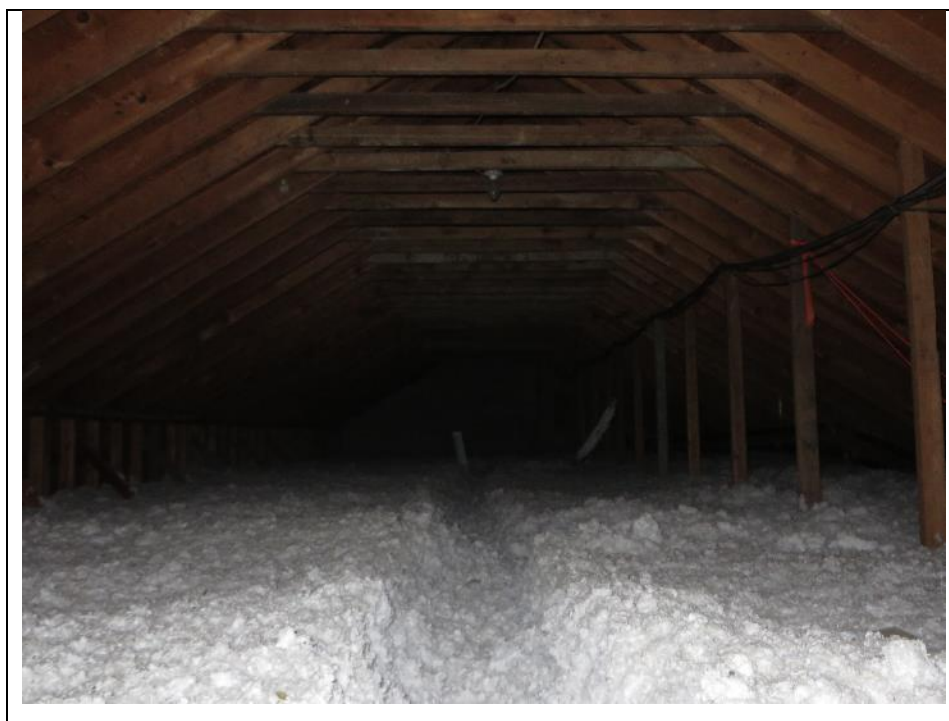
Figure 116. Attic space overview. (AP)
